Tremolite decorative stack-stone wall tiles

This Alert has been issued following WorkSafe Victoria and WorkCover NSW having become aware of the recent importation from China of decorative stack-stone wall tiles that contained asbestos in the form of fibrous tremolite, which is a prohibited hazardous substance.

April 2010

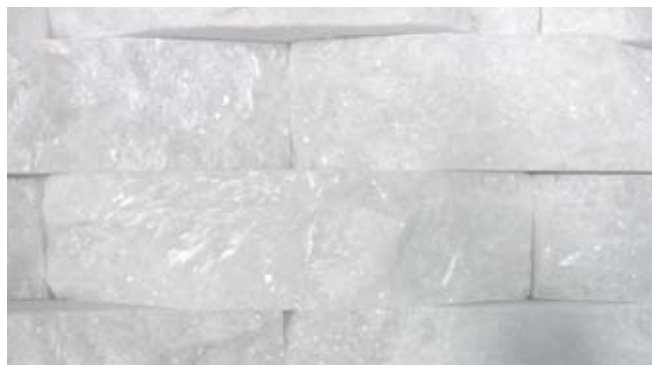
The tile is a bright white colour and has been described variously as 'snow white', 'sparkly white', and 'crystal white', but may be identified by an alternative name or product number.

Tremolite-containing stacked stone wall tiles. Grooves can be felt on the surface of the plates. Note the elongated crystals in centre piece.

Where tiles are identified or presumed to contain fibrous tremolite (or any other forms of asbestos) they should be sealed using appropriate leak-proof containers and transported according to the environment protection regulator for disposal at a licensed asbestos disposal facility.

Tremolite-containing tiles already installed within a workplace or home can be left in place as they pose minimal risk when properly maintained and managed.

- apply a clear sealant to minimise the potential for any release of fibres or dust
- for workplaces, include tremolite-containing tiles in an asbestos register and identify the presence of the tremolite-containing tiles by labelling or other means
- notify workers/contractors of the presence of the tremolite-containing tiles when undertaking any repair, maintenance, refurbishment or demolition works.

Note: Never apply power tools, abrasive cutting, sanding disks or high pressure water guns to the tiles.
